LA-5755

**Demolition of Building 12,
An Old Plutonium Filter Facility**

This report discusses the decommissioning and disposal of a plutonium-contaminated air filter facility that provided ventilation for the main plutonium processing plant at Los Alamos from 1945 until 1973. The health physics, waste management, and environmental aspects of the demolition are also discussed.

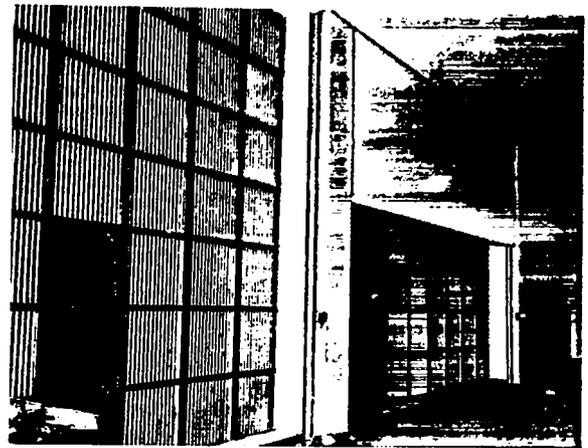
Fig. 9. View of filter banks in 1945.

The next step was to remove all the filters in banks 1 through 4. As shown in Fig. 9, each bank contained 63 filters, each 0.67 by 0.67 m by 0.22 m (2 ft by 2 ft by 8 in.). The filters were lifted out of the frame and put in plastic bags, carried to the access door of the change room, and slipped into another bag held by two laborers. This outer bag was checked for external contamination so that the package could either be rebagged or could be safely carried through the change room to plywood boxes for burial.

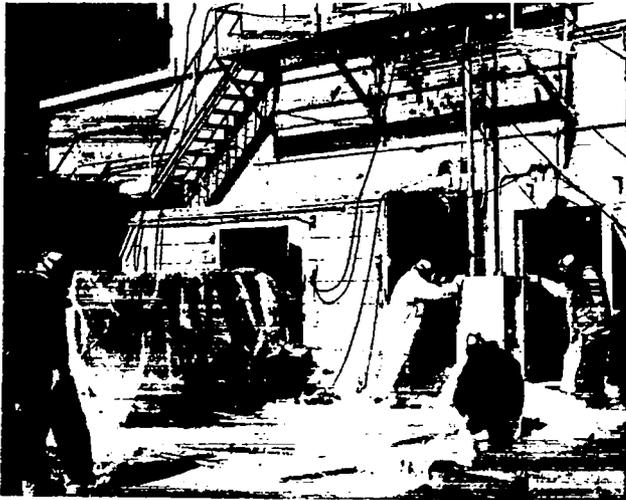
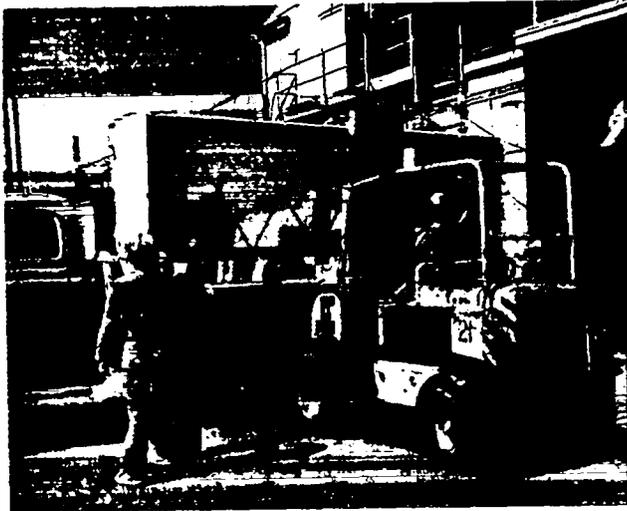
Fig. 10. Precipitron frame being rolled onto plastic sheeting.

Fig. 11. Precipitron frame being wrapped in plastic, ready for loading.

Fig. 12. Precipitron frame ready for hauling to disposal site.

The laborers then began disassembling the precipitron frames. These frames were 1.22 m wide, 0.61 m deep, 4.27 m high, and weighed 275 kg. As soon as a frame was unbolted, it was lowered to the floor with a chain hoist, then cleaned, painted, and placed on rollers

to be moved to an access door of the exhaust blower plenum area (Fig. 3). There, a final coat of paint was applied before the frame was rolled through the door onto a large plastic sheeting. The frame was wrapped in plastic, loaded onto a truck, and hauled to the burial site. Figures 10, 11, and 12 give views of various stages of this operation.

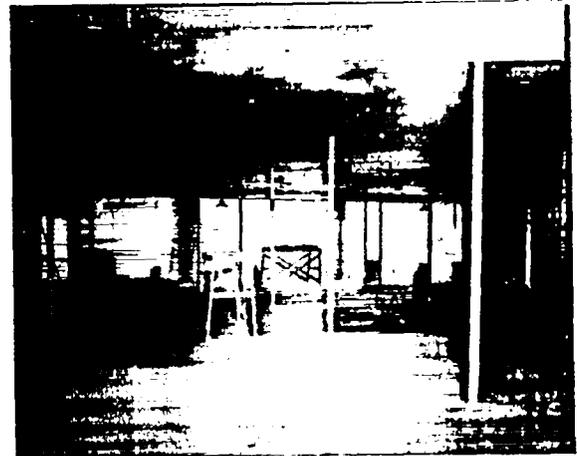
Fig. 15. Intake plenum after stripping and painting.

Demolition of the plenum could now be completed using power equipment to tear down the roof and walls in a normal manner. The appearance of the intake plenum's interior is shown in Fig. 15, and the appearance of the area that housed the precipitrons and filters is shown in Fig. 16.

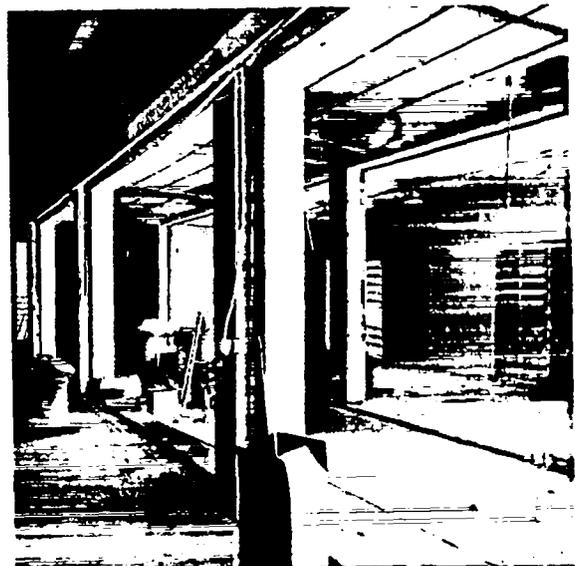
Fig. 16. Precipitron and filter area after stripping and painting.

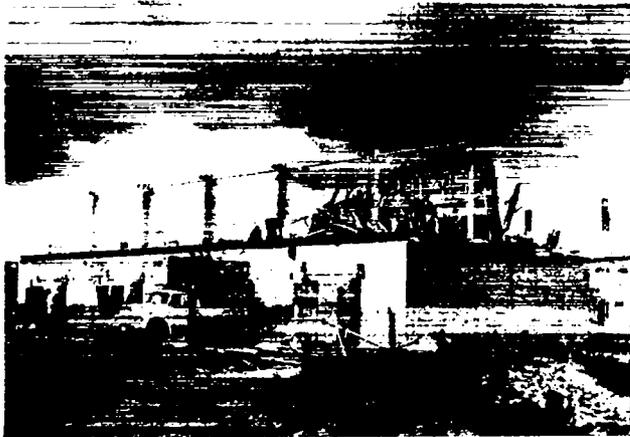
Fig. 19. Ground-level view of penthouse area after removal of most of the walls and roof.

Because no contamination could be detected on the remaining portions of the walls, it was decided to pull the penthouse over with a cable as if it were a normal building being razed. This was done, exposing the steel beam door supports. Figures 19 and 20 show the building with most of the penthouse gone. As portions were pulled down, the long boards were cut into 2.5-m sections with chain saws. The pieces were checked for contamination and then loaded into a dump truck fitted with plywood sides, canvas top, and rear flap. Only rarely was

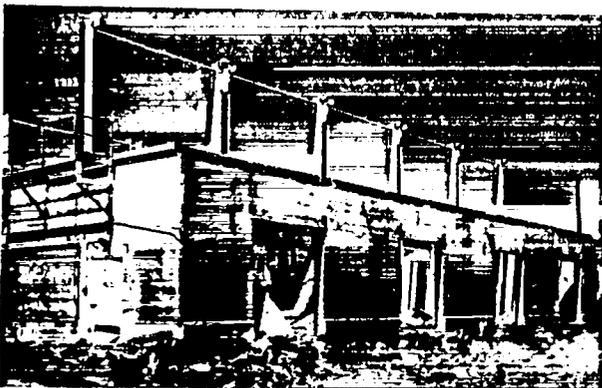
Fig. 24. Precipitron and filter area after blower room and intake plenum were removed.

The next stage was to tear out the intake plenum floor with a payloader. The foundation was extensive, as shown in Fig. 22. The concrete at the point where the external foundation intersects with the internal foundations was often 46 cm thick. The foundation was 1.52 m deep, and because some of the soil inside was contaminated, the decision was made to have the equipment dig deep enough to go beneath the foundation and to load foundation, soil, and floor at the same time. Figure 23 shows the equipment in the process of removing the plenum floor area. When that was completed the building was reduced to the steel, brick and concrete shown in Fig. 24.

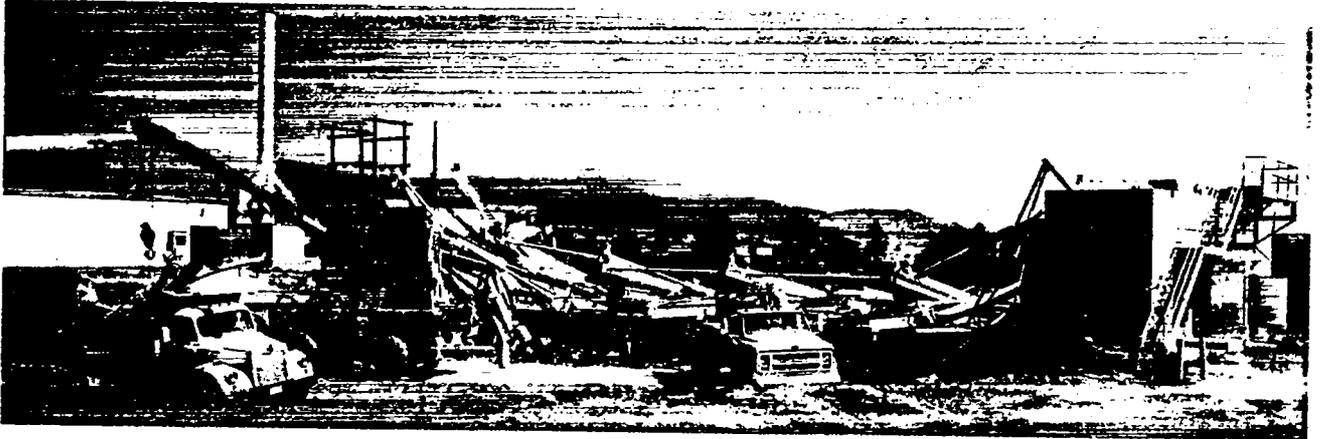
Fig. 26. Cutting steel beams with welding torch.

Fig. 27. Loading steel beams onto truck for disposal.

An attempt was made to pull some of the steel down with a cable and in the process to break some bolts and rivets so that the individual beams could be loaded onto the truck. Unfortunately, the construction was such that when the bulldozer pulled on a piece of steel at the end of the building, the whole steel assembly toppled over and became the tangled mess shown in Fig. 25. The steel then had to be cut apart with cutting torches and loaded onto an open dump truck with a crane. Figures 26, 27, and 28 show various stages of this operation.

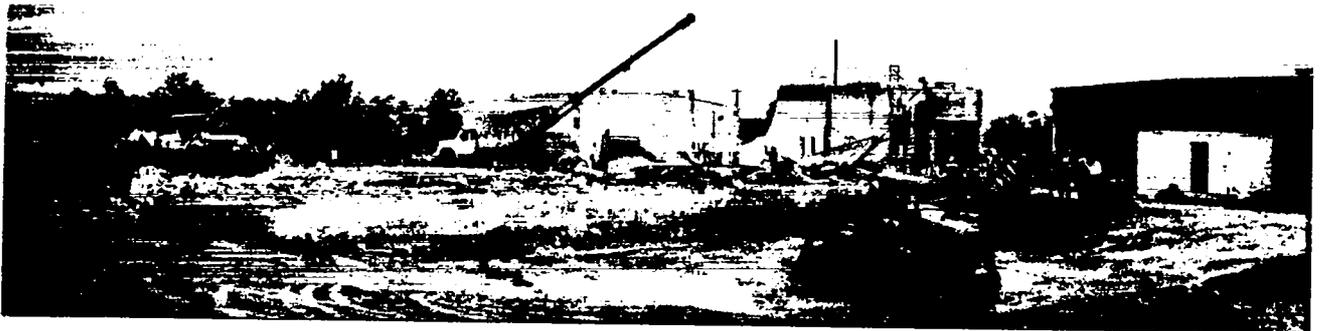
Fig. 28. Precipitron area after most of the steel had been removed.

After the steel was cleared away, only the concrete floor and foundations in the precipitron and filter remained (Fig. 28). The only contaminated areas on the floor

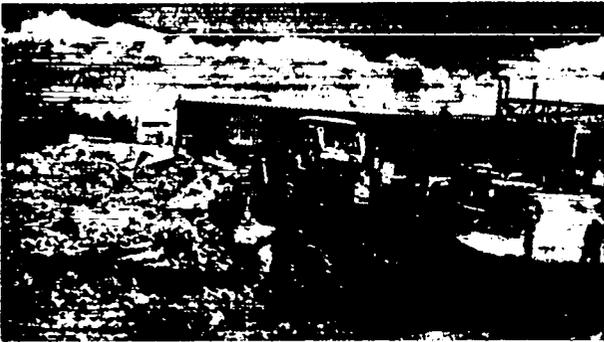
Fig. 29. Bulldozer removing concrete floor in precipitron area.

slabs were the edges that had been in contact with the expansion joints, and these areas were immediately painted. A bulldozer (Fig. 29) was used to lift the floor slabs and push them to an area where the payloader could load them onto a dump truck. Then the bulldozer was used to loosen and break the foundation into pieces small enough to load. Most of the foundation was 15 to 20 cm thick and 1.5 m deep. However, one piece of the foundation was nearly 75 cm wide, 1.5 m deep, and 30 m long. Efforts to break this foundation into small chunks with the bulldozer proved fruitless. Therefore, this 30-m piece of foundation had to be weakened by drilling a series of holes as a perforation line. Part of this perforation line is shown in Fig. 30. The bulldozer was then able to break this foundation into pieces small enough to be lifted onto the truck. Figure 31 shows the removal of the last concrete and dirt from the site.

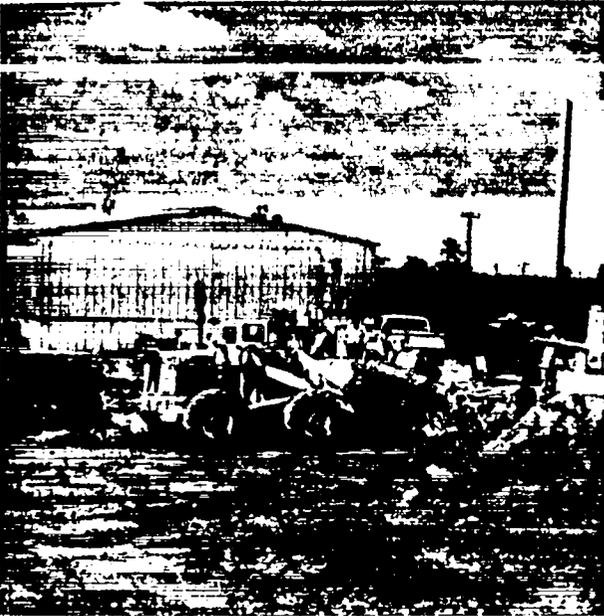
Fig. 31. Removing the last concrete and dirt.

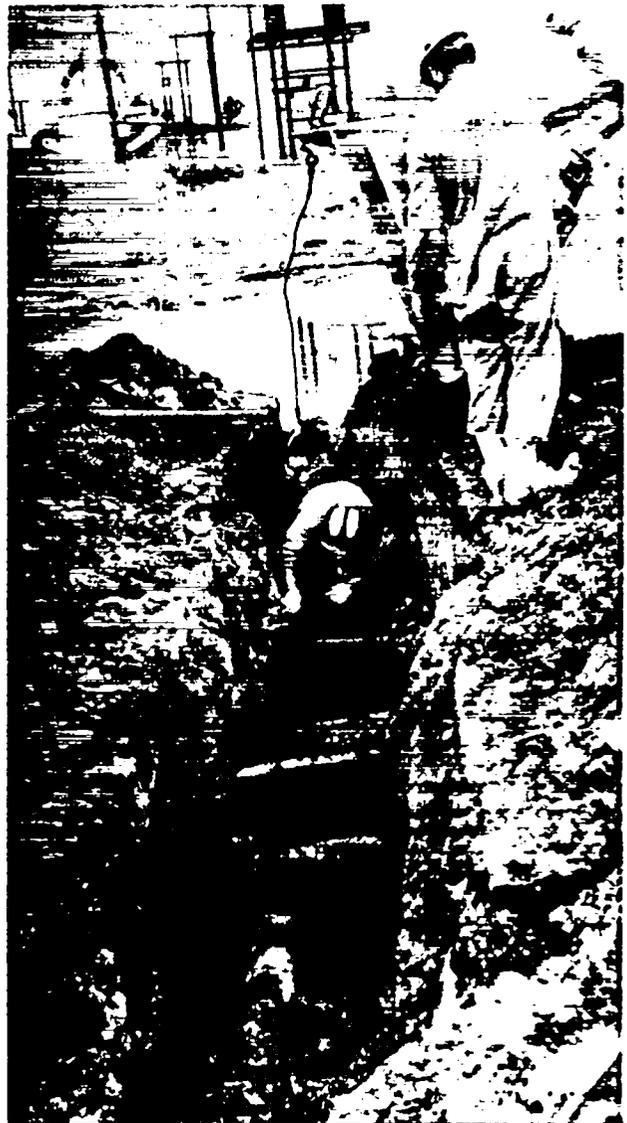
Fig. 32. Removing drain line.

The final task was to remove the drain pipe that led from the precipitron and filter area to a tile field. The tile field had been removed several years earlier, but the plugged drain line remained in place. Workers engaged in removing the drain line are shown in Fig. 32. Although this cast iron drain line had been embedded in the soil for nearly 30 yr, corrosion had penetrated less than 0.16 cm ($< 1/16$ in.).

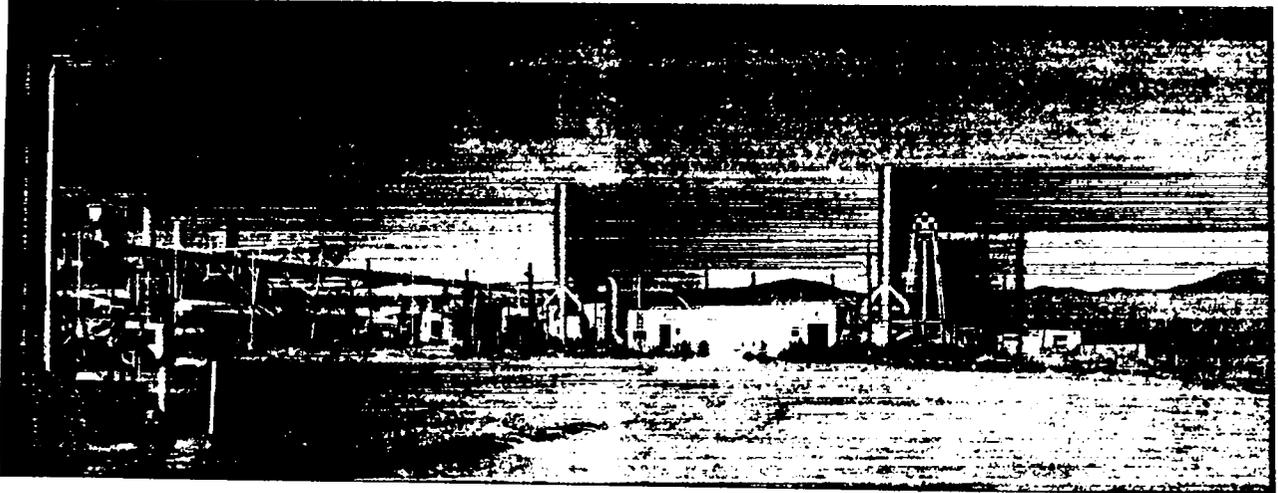
Fig. 33. View of site after completion of demolition.

After the drain line was removed, the trench and the area that had been occupied by the building were surveyed for alpha contamination. When no alpha contamination was detected, soil samples were taken for analyses, the area was backfilled with dirt until the original ground contour was restored, and native grasses were planted as a ground cover. Figure 33 shows the area after completion of the backfilling operation.

The depression was filled with soil from a previous excavation of a trench approximately 300 m due east of the Building 12 site. A composite sample of this fill dirt contained $0.03 \pm 0.01 \text{ pCi/g } ^{238}\text{Pu}$ and $1.3 \pm 0.1 \text{ pCi/g } ^{239}\text{Pu}$. The site was graded to its original natural contour, and the area was seeded with native grasses. The site, after grading and seeding, is shown in Fig. 33.

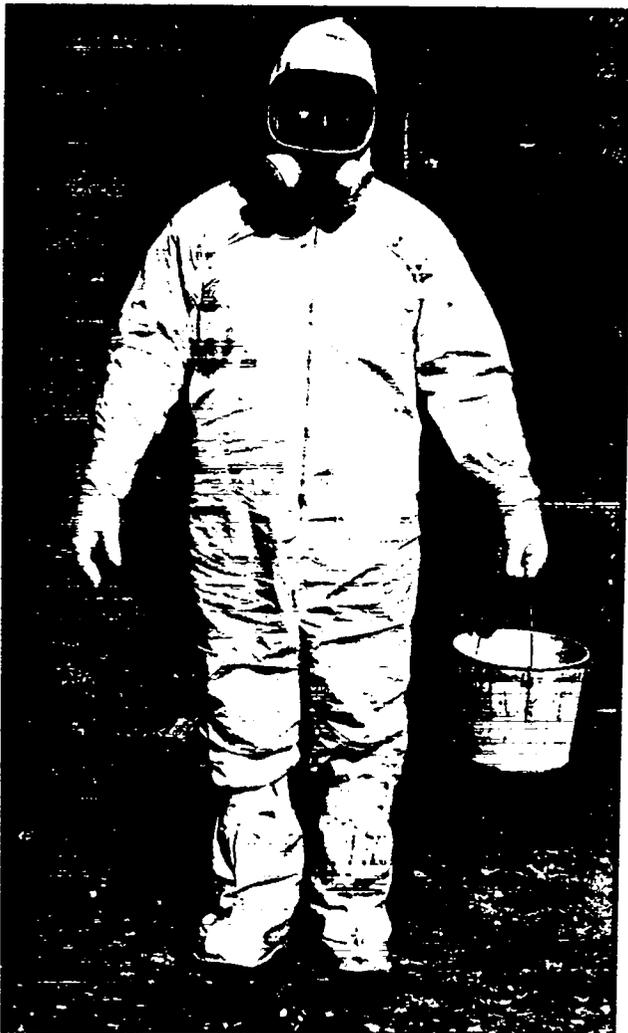
Fig. 34. Worker suited for demolition work.

Demolition workers were provided protective (anti-contamination) clothing for work in the area. For work inside the building, workers were double-suited with coveralls, booties, a cap and hood, gloves, and underwear (Fig. 34). Disposable paper coveralls, hoods, and plastic booties were used for outerwear. The outer garments were overlapped and taped together, and openings in the coveralls were taped shut. This clothing provided adequate protection against worker contamination during the demolition, and no personnel decontamination beyond normal showering and washing procedures was required.
