History of Uranium-233 (^{233}U) Processing at the Rocky Flats Plant

In Support of the RFETS Acceptable Knowledge Program

RS-090-056

1 April 1999

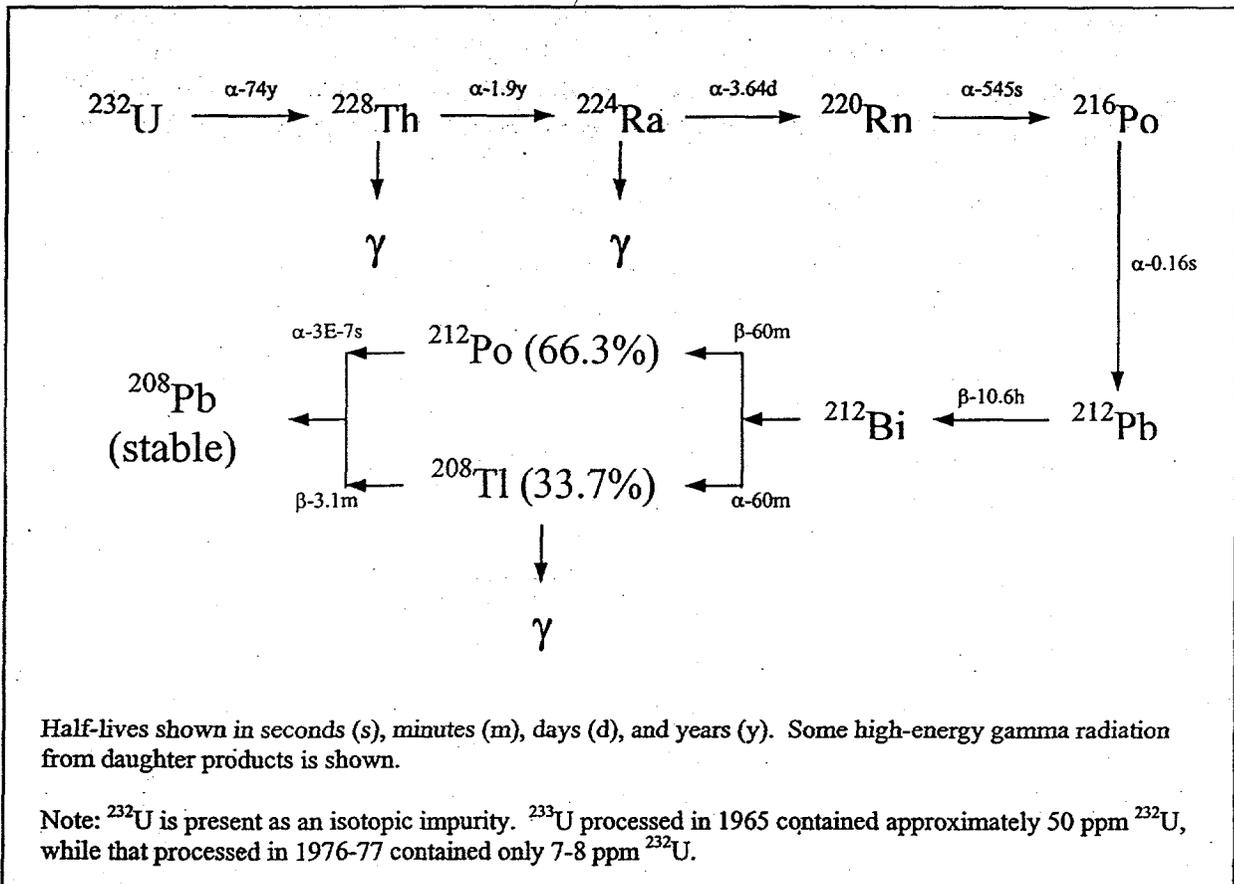
Figure 1 - ^{232}U Decay Scheme.

The first processing operations at Rocky Flats (RF) involving Uranium-233 (^{233}U) occurred in 1965. This project resulted from a special order request to fabricate a number of items out of ^{233}U metal. Feed material arrived at RF from Oak Ridge (OR) in special transport casks as uranyl nitrate solution ($\text{UO}_2(\text{NO}_3)_2$). Isotopic analysis showed ^{233}U composition at 97.13%, with the balance consisting primarily of other uranium isotopes (^{234}U , ^{235}U , ^{236}U , and ^{238}U). In addition, there was a presence of approximately 50 parts per million (ppm) ^{232}U (as a contaminant) which was important because daughter products from its decay [i.e. Thorium-228 (^{228}Th), Radium-224 (^{224}Ra), and Thallium-208 (^{208}Tl)] give off high-energy gamma radiation¹, which presents a significant external health hazard to processing workers. Figure 1 summarizes the decay scheme for ^{232}U to stable ^{208}Pb , and shows the points where high energy radiation is released.

¹ For example, 79.5% of ^{208}Tl gamma is in excess of 100 keV, with 36% emitted as 2.614 MeV gamma. RFP-2817, Chemistry R&D Semiannual Progress Report for January - July 1978, 2/10/79.

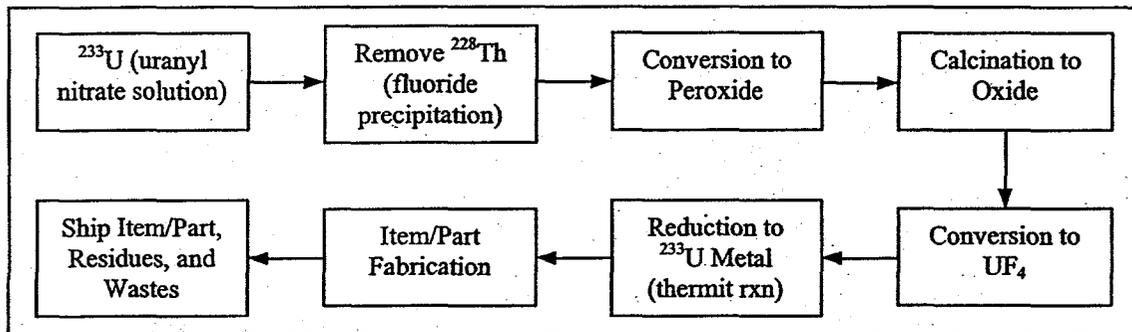
Figure 2 – ^{233}U Processing Steps.

Because of this hazard, plans for processing of ^{233}U focussed on isolating it from other RF plutonium (Pu) and uranium (U) process streams. The first step involved precipitating Th (and a small amount of Tl) from the feed material in order to minimize their associated radiation hazard. Subsequent processing steps were then expedited in order to minimize the build-up of ^{232}U decay products over the time that processing occurred. The flow path in Figure 2 summarizes the ^{233}U processing steps.

^{233}U processing² began in Building 771³ where the uranyl nitrate solution was transferred to receiving tanks. Fluoride precipitation was then used to remove the “hot” (highly radioactive) daughter products (primarily ^{228}Th), and the uranium was converted to peroxide. The peroxide was shipped to Building 881 where it was calcined to an oxide, which in turn was converted to uranium tetrafluoride (UF_4), and reduced to ^{233}U metal using a thermit reaction. The metal was then cast into feed ingots, which were in turn recast into pieces from which the final parts were fabricated. Casting and machining operations took place in Building 881, while other fabrication steps were handled in Building 883. Final component assembly and inspection occurred in Building 777.
